Module Measurements at LBL

K. Einsweiler, J. Richardson LBNL

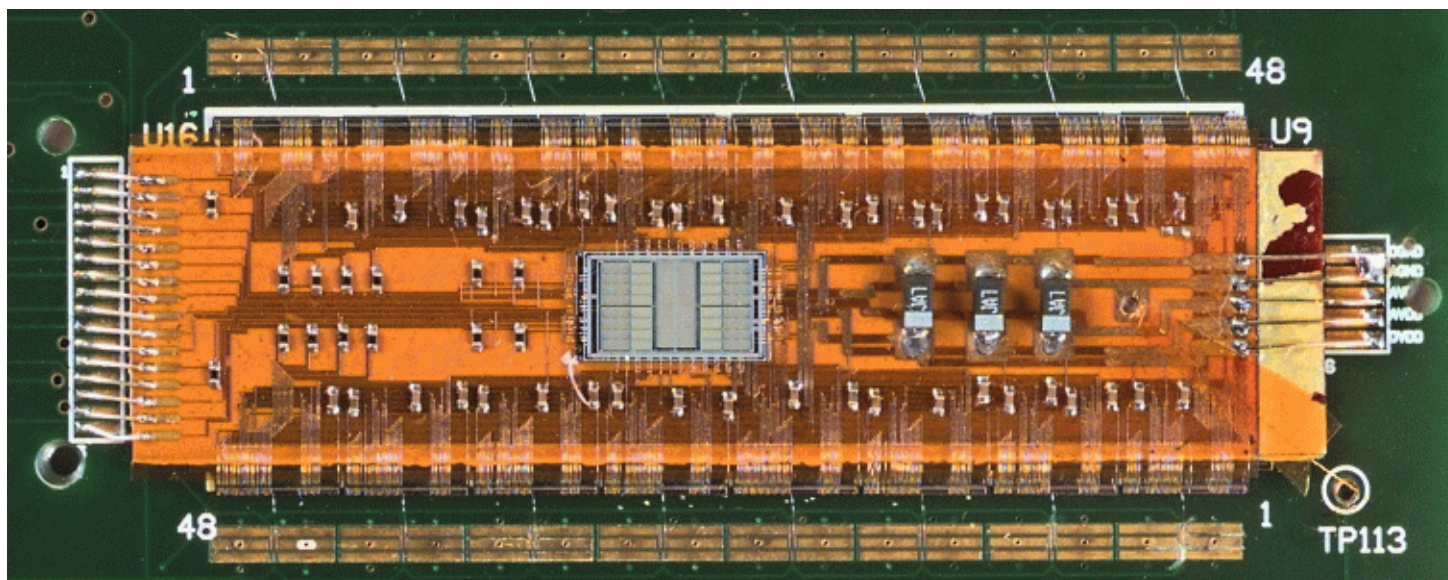
- First two modules were received in June 98. They were built up as bare modules using the first Genova support card. First test results were available in Sept. 98, and showed many problems with noise and stability.
- Third module, made with 150 μ thick die, was built using Flex1.0 and tested in Nov. 98, and showed similar noise and stability problems. Indications from single chips were that there was a significant problem with Boeing bump resistance.
- All three of these modules had all 16 FE chips working perfectly under digital testing.
